Manhole Inspection Summary

Manhole # S29MM1006MH

Insp Date: **4/23/07 10:19 AM**

Location Address: **4417 SEDWICK RD**

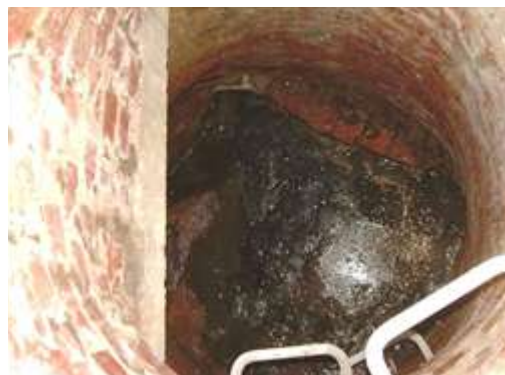
Top View

Bench and Channel debris.

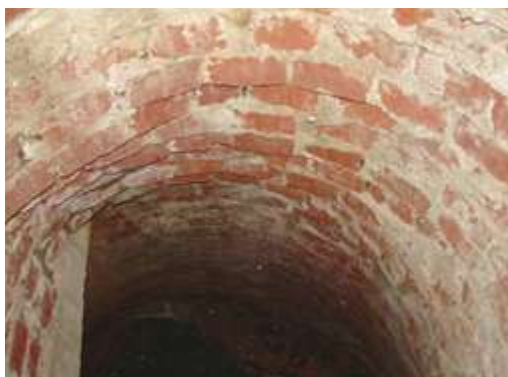
Defect

Infiltration: ☐ None ☒ **Joint** ☐ Cracks ☐ Mortar ☐ Roots ☒ **Wall**

Infiltration: ☐ None ☐ Joint ☐ Cracks ☒ **Mortar** ☐ Roots ☒ **Wall**

Adjustment and Barrel infiltration.

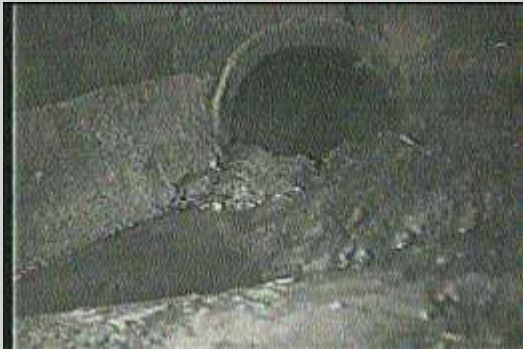
8 in. Circular Gravity Sewer Pipe Out @ 12 O'Clock

Deposits: ☐ None ☒ **Mud** ☐ Sludge ☒ **Debris** ☐ Grease

Silt Depth: **3** (in.) Deposits Extent: **Medium**

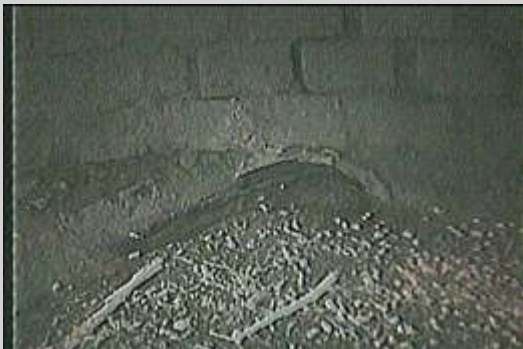
6 in. Circular Gravity Sewer Pipe In @ 3 O'Clock

Deposits: ☐ None ☒ **Mud** ☐ Sludge ☒ **Debris** ☐ Grease

Silt Depth: **4** (in.) Deposits Extent: **Heavy**

Infiltration: **Evidence** Pipe Seal Cond: **Unknown**

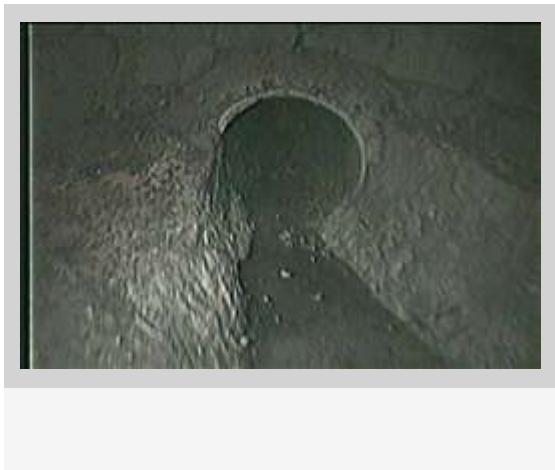
6 in. Circular Gravity Sewer
Pipe In @ 8 O'Clock

Deposits: ☐ None ☒ **Mud** ☐ Sludge ☒ **Debris** ☐ Grease

Silt Depth: **1** (in.) Deposits Extent: **Light**

Infiltration: **None** Pipe Seal Cond: **Cracked**
